GRAND FORKS/ EAST GRAND FORKS SCHOOL SAFETY STUDY SUMMARY

Grand Forks - East Grand Forks Metropolitan Planning Organization

Introduction

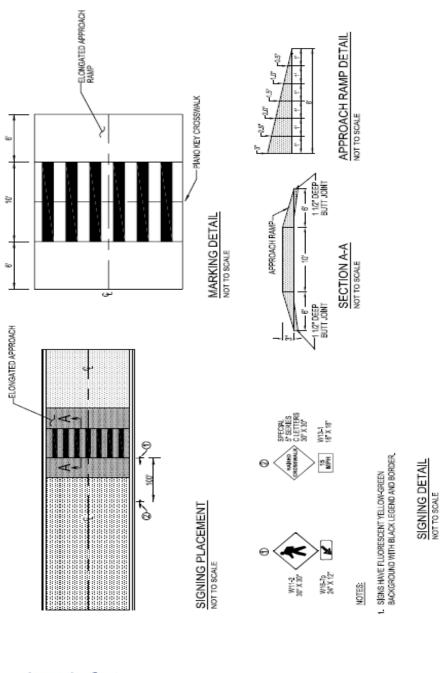
Figure 18: Design Detail of a Raised Crosswalk.

Raised crosswalk for north loading/unloading area	The construction of raised crosswalk for the school's main entrance could make safer crossing for pedestrians by reducing speeds and deterring parking over the crosswalk.	\$7,500 - \$15,000 Estimated 2014 Cost	NOT COMPLETED

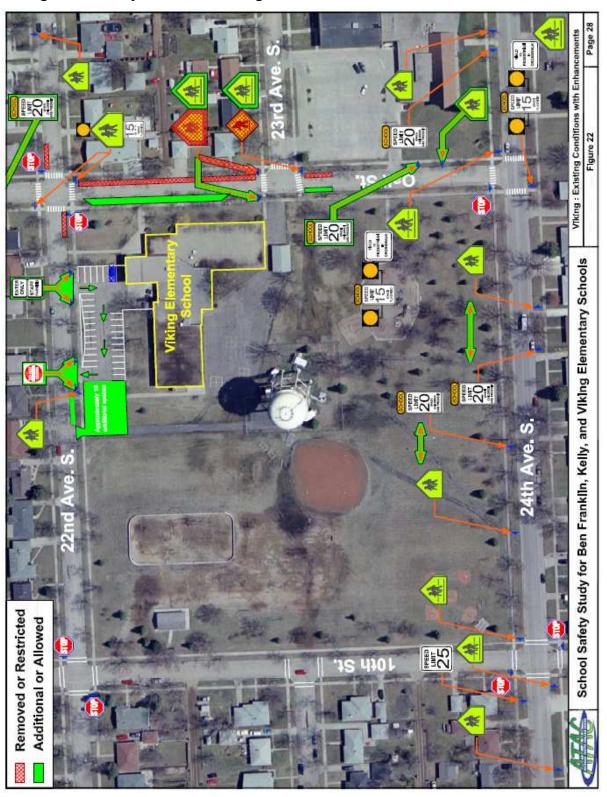
Viking Elementary School Existing Conditions and Enhancements

ATAC	FEEDBACK	PROGRESS
Expand the North Parking lot to the west	Have vehicles enter the lot from the east driveway and exit from the west driveway. In addition, a handicap bus parking stall could be added to the North parking lot. The parking lot could also be expanded to the west, providing approximately 18 more parking stalls.		NOT COMPLETED
Move school bus/van parking to 22 nd Ave South (west of parking lot) and Oak Street (south of 23 rd Ave South)	Parking for the large school buses can be moved to the south side of 22 nd Ave South and west of the parking lot. In addition, school bus/van parking can exist along the west side of Oak Street South of 23 rd Ave. South.		NOT COMPLETED
Construct a loading turnout lane along the west side of Oak	Traffic flow along Oak Street is impeded especially during the dismissal time. This can be attributed to allowing parking on		NOT COMPLETED

Street	both sides of the two-way streets. It is recommended to prohibit	
	parking/loading along the east side of the street during school	
	hours. This option would eliminate	
	midblock crossings by students accessing vehicles. Since it was	
	recommended to move the school bus/van parking, the west side of	
	Oak Street between 22 nd Ave South area would provide safer	
	loading zone.

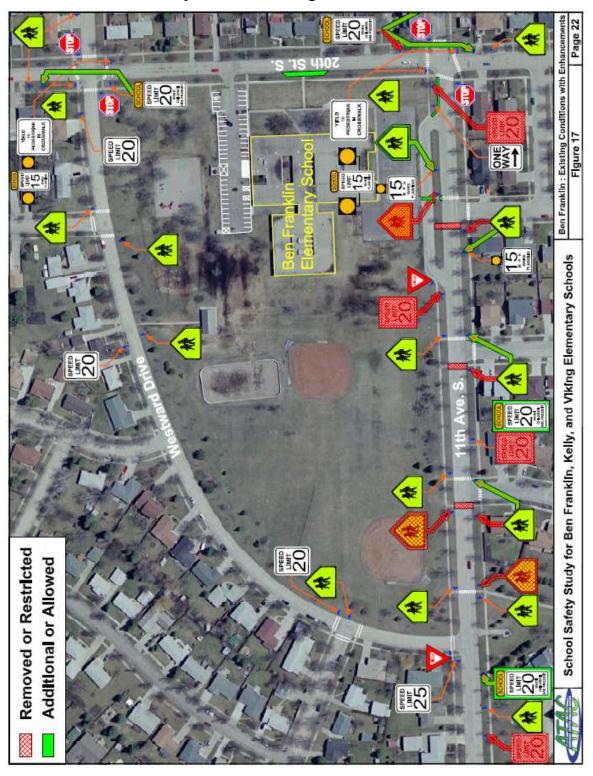
Ben Franklin Elementary School Existing Conditions with Enhancements

ATAC	FEEDBACK	PROGRESS
Construct a speed table and curb ramps for turnout	To assist pedestrian safety within the turnout area, a raised pedestrian crosswalk could be constructed at the west driveway of the playground. Curb ramps should be installed at the east sidewalk within the boulevard.		COMPLETED

Construct bus loading turnout lane along 20 th Street	Travel lanes along 20 th Street can be restricted when vehicles are parked along the east side and buses are parking along the west side of the street. A bus turnout lane at the current bus loading zone would provide an additional level of safety for school children.		NOT COMPLETED
--	--	--	------------------

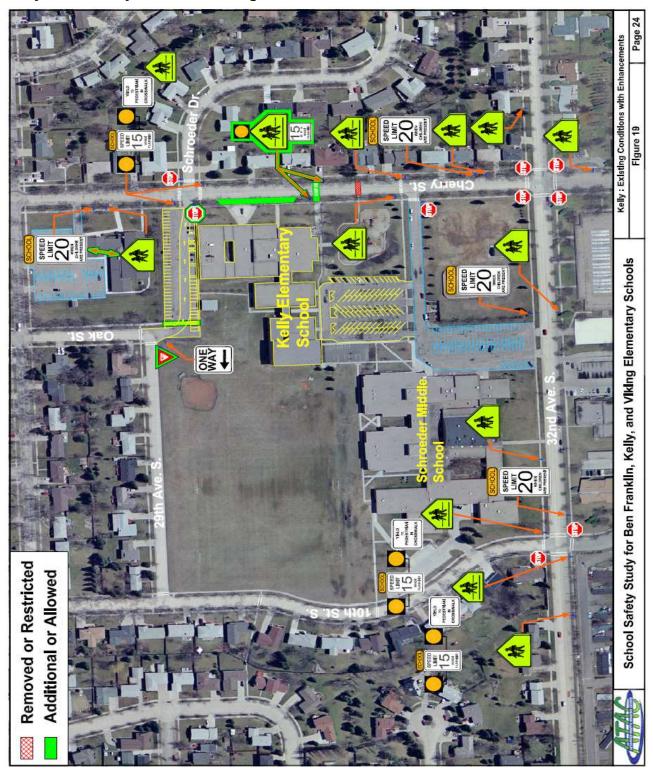
Kelly Elementary School Existing with Enhancements

Install a STOP sign for vehicles exiting the north parking lot	Some confusion was evident to who had the right-of-way. Therefore, it is recommended to install a STOP sign at the exit of the parking lot, which is the minor street approach.		COMPLETED
Add a mid-block crosswalk and flashing beacons between Schroeder Drive and the access road	To assist in pedestrian safety crossing Cherry Street it is recommended to create a midblock crosswalk south of the bus loading zone. The crossing can also incorporate a speed reduction and beacon.	Want to discourage mid-block crossing.	UNDER REVIEW

ATAC	FEEDBACK	PROGRESS
Modify the crosswalk in the north parking lot	A crosswalk is painted within the north parking lot. Not only does the crosswalk paint match the parking stall paint, it is also located within a parking stall. At a minimum, the pedestrian crossing should be painted white and the parking stall should be removed.		
Construct a bus turnout lane along the west side of Cherry Street	The turnout lane along with proper signs should reduce the number of illegal parking occurrences and improve pedestrian/vehicle safety.		NOT COMPLETED
Remove the playground crosswalk located north of the access road	The crossing is in close proximity to both the proposed mid-block crossing and access road crossing and it has not been maintained very well.		COMPLETED

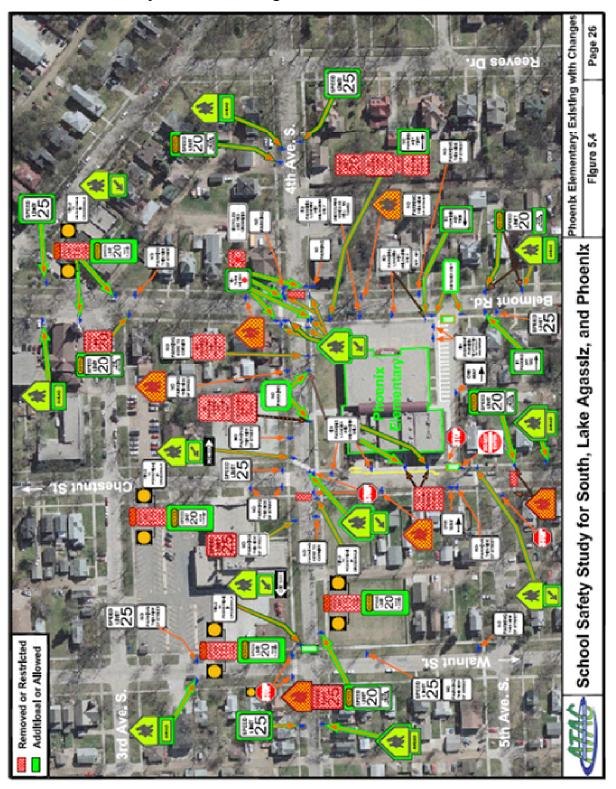
Phoenix Elementary School Existing Conditions with Enhancements

ATAC	FEEDBACK	PROGRESS
Add a turn-out lane on Belmont Road next to the school	This would provide a safer parking option for parents during dismissal period, & help to reduce blockage of passing vehicles	\$11,250 - \$16,750 Estimated 2014 Cost	NOT COMPLETED
Add additional lane to the driveway exiting the south parking lot onto Chestnut Street	Adjust the angle of the parking in the south parking lot from 90 to 60. This would encourage a none-way flow in the parking lot, and improve the sight of drivers when backing out. Add an additional lane exiting the south parking lot to the west and create a double right turn at the intersection. Due to the one-way operation of Chestnut St. it may be difficult for vehicles to exit the south parking lot. A two-way operation could improve traffic flow exiting the school.	The school has made other changes that were not in the recommendations that have improved traffic flow at the school. \$34,250 - \$40,000 Estimated 2014 Cost	NOT COMPLETED

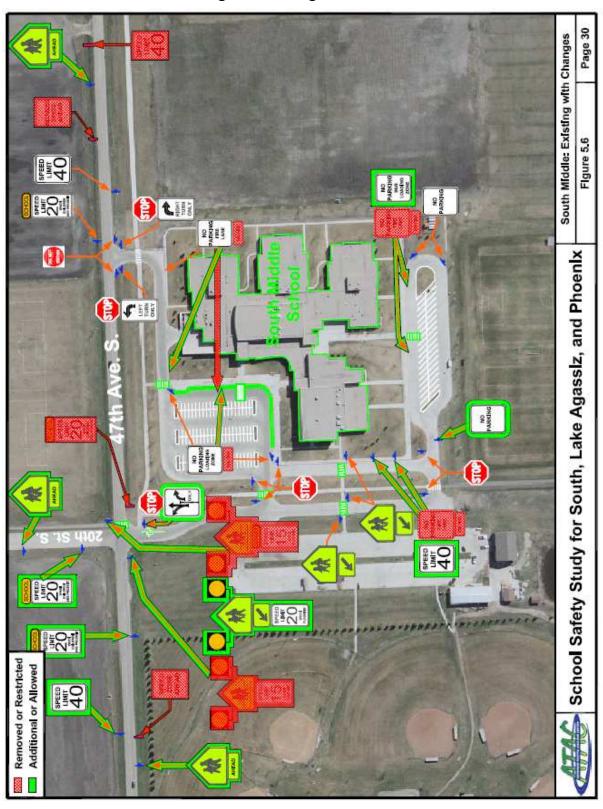
South Middle School Existing with Changes

ATAC	FEEDBACK	PROGRESS
Add a curb/sidewalk and border to the north parking lot along with a raised crosswalk from the main entrance. Change the vehicle flow to a one-way along the entire side of the school	Add a curb/border and sidewalk to the north parking lot to channelize traffic flow. The raised crosswalk could be added to provide a more visible crossing into the parking lot, and discourage parking on the crosswalk. This will increase the number of parents willing to park in the parking lot, after which they can exit to the west. Bollards can be placed at the northeast corner	\$31,500 - \$37,250 Estimated 2014 Cost	NOT COMPLETED

of the parking lot which can be removed during special events and snow removal.	
Change the orientation of the south parking lot to a 90° alignment	So drivers can access the parking stalls easier, but still maintain the channelized flow around the parking lot.	Parking remains at a 60°; however, it's now in the same direction as traffic flow. The school also instituted a new drop off procedure in the morning due to near misses at crosswalk. Drivers are prevented from creating multiple lanes of traffic. \$11,750 - \$15,750 Estimated 2014 Cost

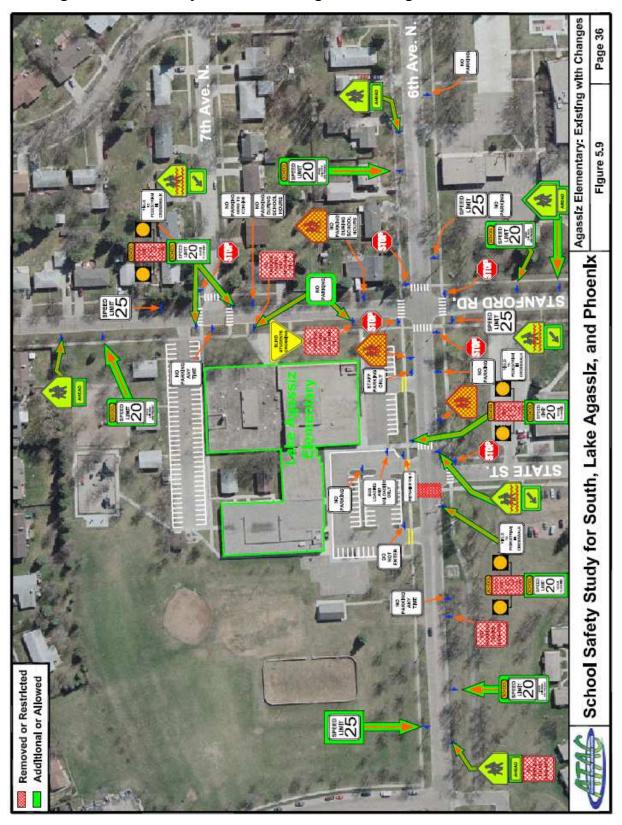
Lake Agassiz Elementary School Existing with Changes

ATAC	FEEDBACK	PROGRESS
Add a turn-out lane on Stanford Road next to the school	Also, the access road is changed to a northbound one-way to reduce any potential vehicle conflicts. A turn-out lane is also added to Stanford Road on the near side of the school to provide a safer loading and unloading zone for students.		COMPLETED
Reduce the size of the bus lane and join with the one-way access road on the west side of the school	Move the driveway farther away from the intersection of 6 th Ave. N and Stanford Road and joins the bus lane with the access road to the west.		COMPLETED
Remove the bus lane and increase the capacity of the southwest parking lot	Since a loading zone is already provided along the access road. The southeast parking lot is also removed, but the capacity of the southwest parking lot is increased.	\$58,250- \$71,500 Estimated 2014 Cost	
Remove the bus lane and join both parking lots on the south	Join both of the south parking lots and removes the east driveway to be in compliance with the city	\$34,700 - \$45,900 Estimated 2014 Cost

side	specifications. A turn-out lane is also added to Stanford Road. This option provides the most parking capacity while still maintaining traffic flow around the school.		
Make the access road a one-way operation and combine the north approaches	Utilizes a bus lane on the south side of the school, which is situated to account for access control issues. It also provides a one-way movement on the access road to the west of the school, and combines the two approaches in the north parking lot.	The school was in the process of expanding when the study was done. These recommendations were incorporated into the new parking lot.

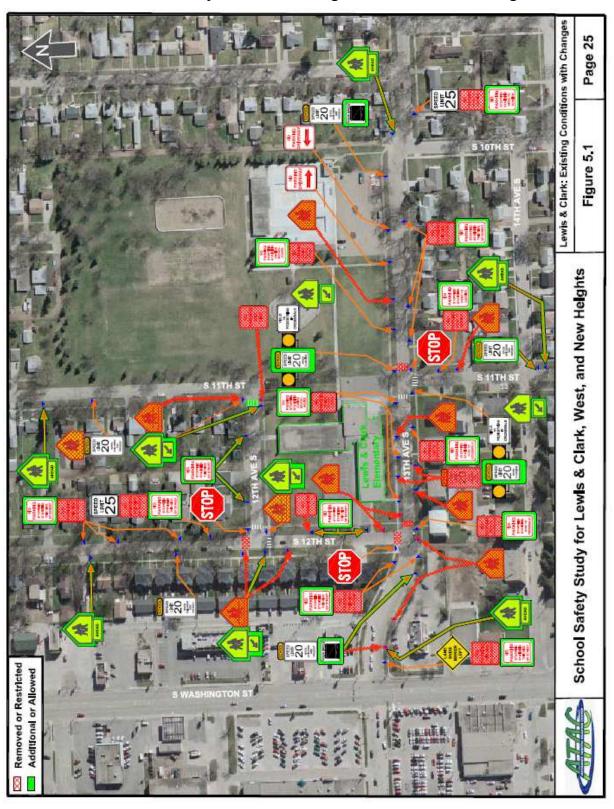
Lewis and Clark Elementary School Existing Conditions with Changes

ATAC	FEEDBACK	PROGRESS
Increase the capacity of the staff parking lot, with a drive- through lane around the perimeter	Increasing the capacity will free up the parking lot can be expanded to increase capacity. Increasing the capacity will free up the parking space along the streets, which is currently being used by staff members. Along with the expansion of the parking lot, a second driveway was added to provide better access. To keep vehicle flow uniform in the parking lot, the driveways utilize one-way operations. A second geometric change is to provide a drive-through area around the perimeter of the staff parking lot, with a raised curb to separate the parking lot from the drive-through. This would provide a loading and unloading area for parents, and would alleviate the parking on 12 th Ave S.	\$239,750 - \$312,750 Estimated 2014 Cost

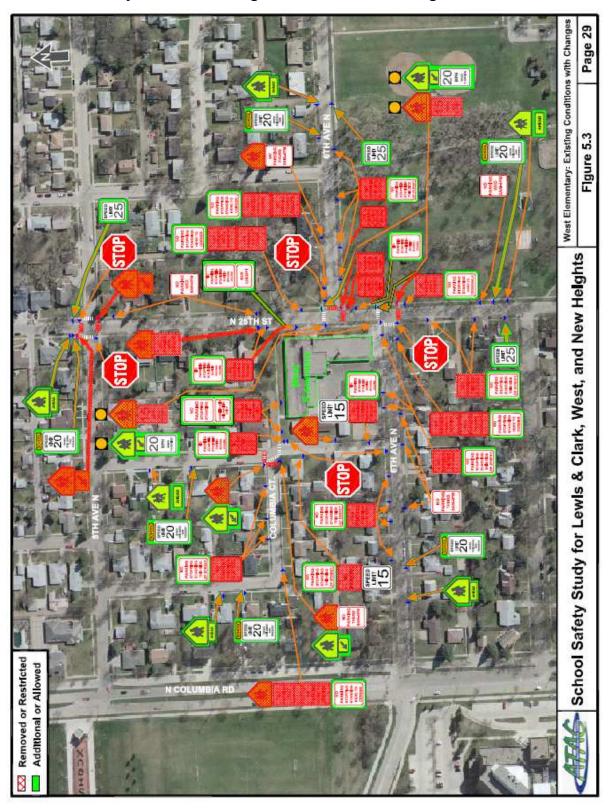
West Elementary School Existing Conditions with Changes

ATAC	FEEDBACK	PROGRESS
Increase the capacity of the current staff parking lot	Expanding the parking lot to the west will provide sufficient parking for all staff, which will improve the parking capacity in the streets. In addition, adding a curb/border to the parking lot will help in maintaining a separation between the parking lot and the adjacent playground.	\$41,500 - \$60,750 Estimated 2014 Cost	
Pave the east-west section of the alleyway on the north side of the school and extend to the east as an access road to N 25 th Street with parking along the north side of the school	This extension will provide additional access to N 25 th Street and will serve as an alternative to the alleyway which extends to the north. The one-way operation will help to maintain efficient traffic flow around the school. In addition, diagonal parking is proposed along the north side of the school, accessed by the new roadway. This will provide additional parking for school faculty and staff.	\$71,000 - \$100,000 Estimated 2014 Cost No longer a bus loading area. Improvements need to be requested by owners.	ON GOING

Add a bus turn-out lane in west alley for loading/unloading	The re-location of the bus loading to the west side of the school creates a safer environment for students, as the busses are moves from surrounding roadways.	\$20,500 - \$28,500 Estimated 2014 Cost	NOT COMPLETED

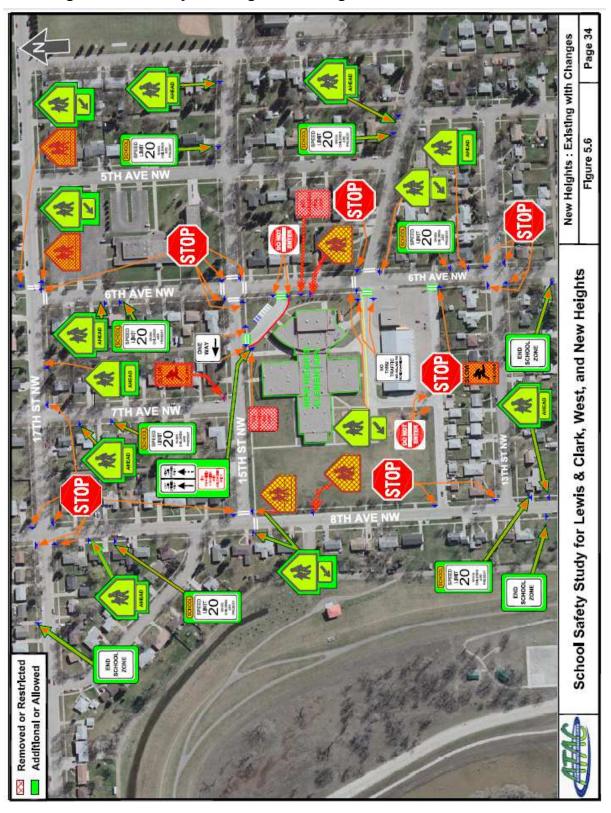
New Heights Elementary Existing with Changes

ATAC	FEEDBACK	PROGRESS
Add a staff parking lot to the northwest side of the school	Current staff parking is limited to the surrounding streets and adjacent to the bus garage on the south side of the school. The addition of a staff parking lot will significantly improve the parking capacity on the surrounding streets, primarily along the near-side curb on 15 th St. NW. This will allow parents increased access to the school during pick-up and drop-off activities, and could potentially reduce the number of vehicles using the drive-through area.	\$153,000 - \$206,750 Estimated 2014 Cost	NOT COMPLETED

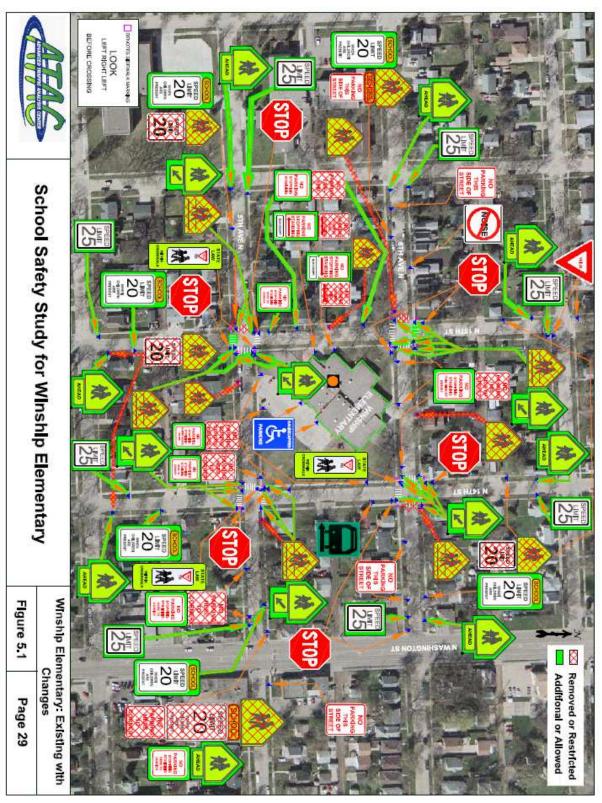
Winship Elementary School Existing with Changes

ATAC	FEEDBACK	PROGRESS
Add a turn-out lane	This will help to expand N 15 th St		
to the west and north	and reduce congestion caused by		
sides of the school	parents parking along both sides of		
	the street. A turn-out lane was

provided on the south side of 6 th Ave N which should provide additional on-street parking for parents and help to minimize congestion on N 15 th Street.		
Add an additional one-way access to the staff parking lot from North 4 th Street	This would allow parents to have and off-street means of picking up the students being dismissed from the south door adjacent to the staff parking lot. It should be noted that implementing this option would require an increased level of enforcement by school staff to ensure safety of students using the greenspace/playground on the east side of the school after dismissal.	\$51,500 Estimated 2014 Cost

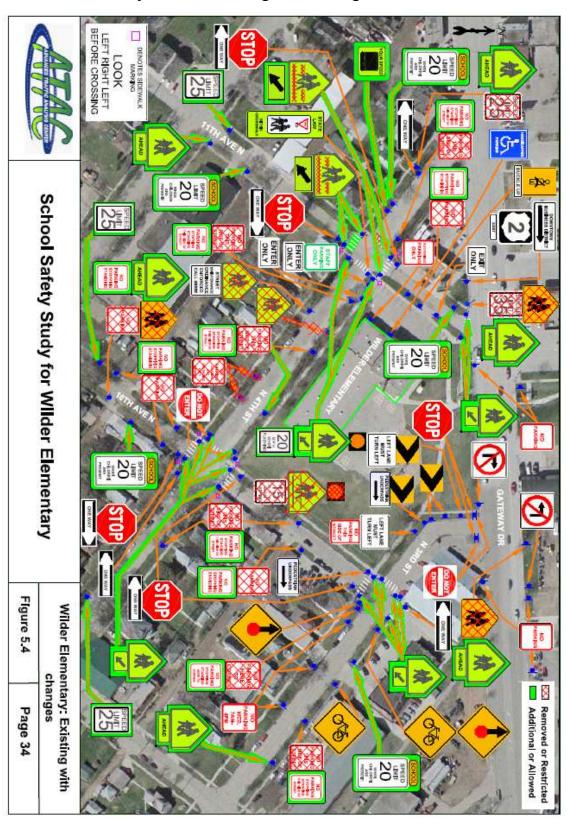
Wildier Elementary School Existing with Changes

ATAC	FEEDBACK	PROGRESS
Increase the capacity of the current staff parking lot	The parking lot capacity is insufficient for the number of staff at the school and the overflow of parking scattered among the surrounding streets. Expanding the parking lot to the northeast will provide sufficient parking for all staff. It will provide more room for the bus loading area.	\$9,250 Estimated 2014 Cost

On N 4th Street is a none-way and parents are parking along both		
Add a turn-out lane on North 4 th Street and 10 th Ave North	sides of the street, it is recommended that a turn-out lane be added on the east side of the street to help reduce congestion and keep both lanes open.	\$40,250 Estimated 2014 Cost

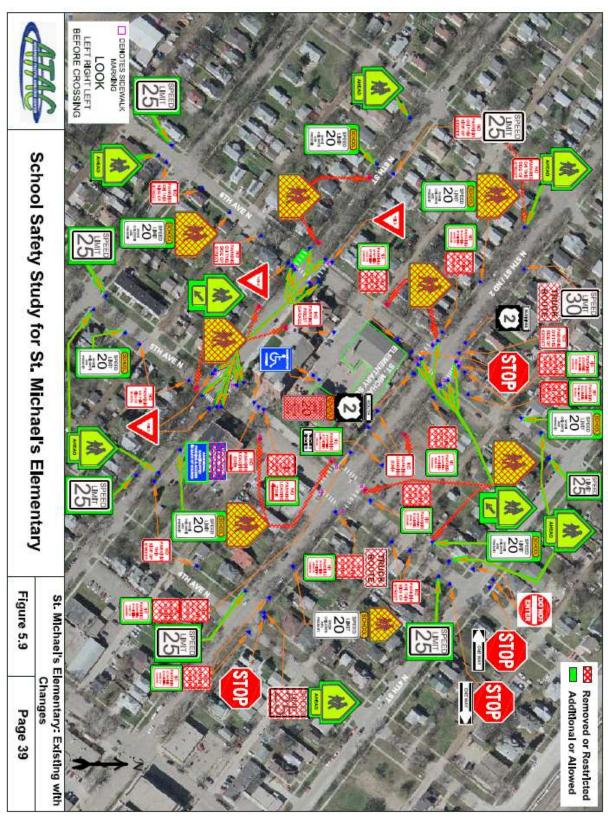
St. Michael's Elementary School Existing with Changes

ATAC	FEEDBACK	PROGRESS
Encourage parents to use the parking lot to the east of the school	There is minimal space around the school for parking facilities; the parking lot across the street to the east has ample space for both staff and parents. It is recommended that parents be encouraged to use this parking lot to reduce the number of on-street parking adjacent to the school.		
Encourage staff to enforce parking restrictions and to take a proactive approach to educating parents on safe practices	The enforcement strategies should place an emphasis on communication with parents when issues are observed. If recurring issues occur, requests can be made to law enforcement officials.

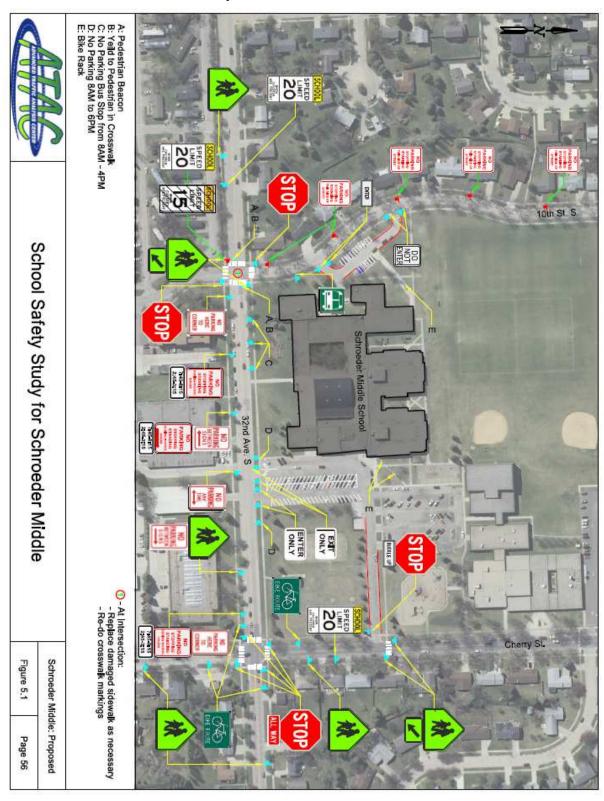
Schroeder Middle School Proposed

ATAC	FEEDBACK	PROGRESS
Repair/replace the faulted sidewalk around the intersection of 32 nd Ave South and South 10 th Street	The stretch of faulted sidewalk around the intersection 32 nd Ave S and S 10 th Street be repaired or replaced as necessary.		COMPLETED
Consider installing Pedestrian Hybrid beacons if allowed per MUTCD guidelines	It is recommended that the intersections around Schroeder Middle School that currently have flashing pedestrian beacons be studied as per the MUTCD to check if they meet the warrant for Pedestrian Hybrid Beacons.	\$21,750 Estimated 2014 Cost Cannot be installed at intersections per MUTCD 2009	NOT APPLICABLE
Targeted enforcement is recommended as and when deemed necessary by the concerned Law Enforcement	The public needs to be re-educated on safe use of the roadway network especially while walking or biking. The public should be encouraged to share the road while on pedalcycles and not go against the traffic. The use of safety gear such as		NOT COMPLETED

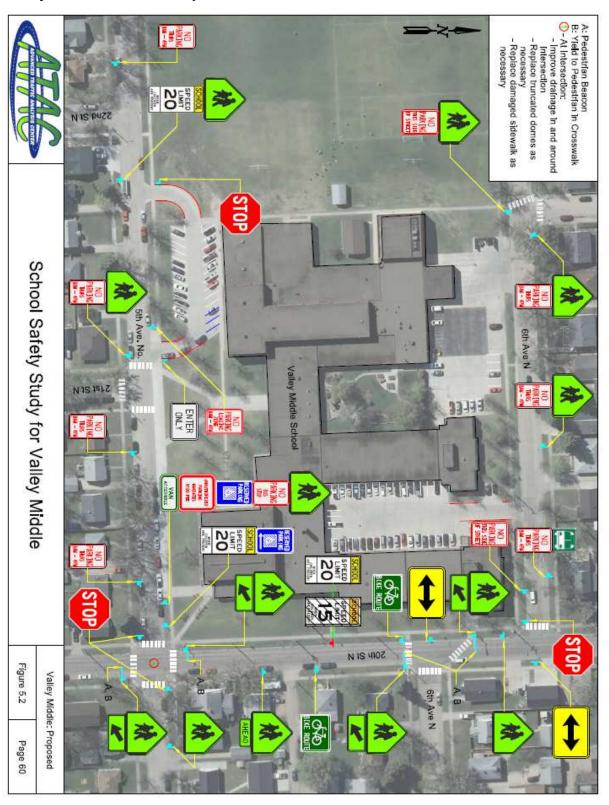
Valley Middle School Proposed

ATAC	FEEDBACK	PROGRESS
Repair/replace the faulted sidewalk around the intersection of North 20 th Street and 5 th Ave North	The sidewalk and crosswalk near the intersection of S 20 th Street and 5 th Ave North has faulted and cracked	Property owners are responsible for the sidewalk adjacent to their property. Referred to sidewalk replacement program	COMPLETED
Improve drainage conditions around the intersection of North 20 th Street and 5 th Ave North	The intersection of S 20 th Street and 5 th Ave North.	Referred to sidewalk replacement program	
Add a parking lot in the Southwest corner of the school premises	To solve the lack of parking spaces, it is recommended that an additional parking lot be constructed in the south-west of the school premises.		NOT COMPLETED
Consider installing Pedestrian Hybrid Beacons if allowed per MUTCD guidelines in the near future	The flashing pedestrian beacons be studied per the MUTCD to check if it meets the warrant for Pedestrian Hybrid Beacons.	Cannot be installed at intersections per MUTCD 2009. All the schools are also under review for the signage.	NOT APPLICABLE

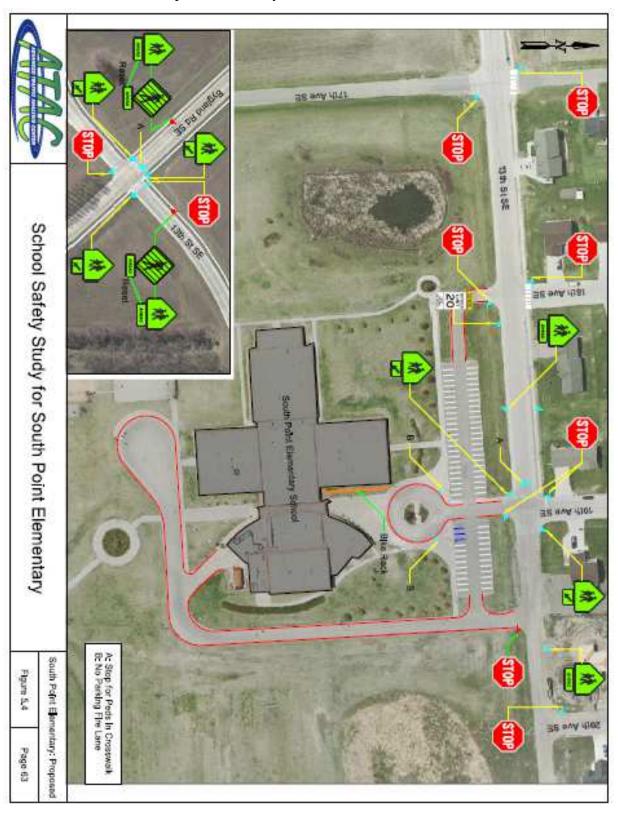
South Point Elementary School Proposed

ATAC	FEEDBACK	PROGRESS
Add a parking lot on the east end of the school premises	It is recommended that the new parking lot be located on the east side of the school premises.		NOT COMPLETED
Redesign the two narrow driveways	The current throat width of the two driveways occasionally forces vehicles to stop/yield until the driveway has been cleared by the oncoming vehicle. The driveway leading to the circle in front of the main entrance should also be		NOT COMPLETED

widened similar to the two driveways.	
Targeted enforcement is recommended as and when deemed necessary by the concerned law enforcement agencies		ON GOING
