Near Southside Historical Neighborhood Traffic Study

Final Report

October 2018

Prepared for:
Grand Forks-East Grand Forks MPO

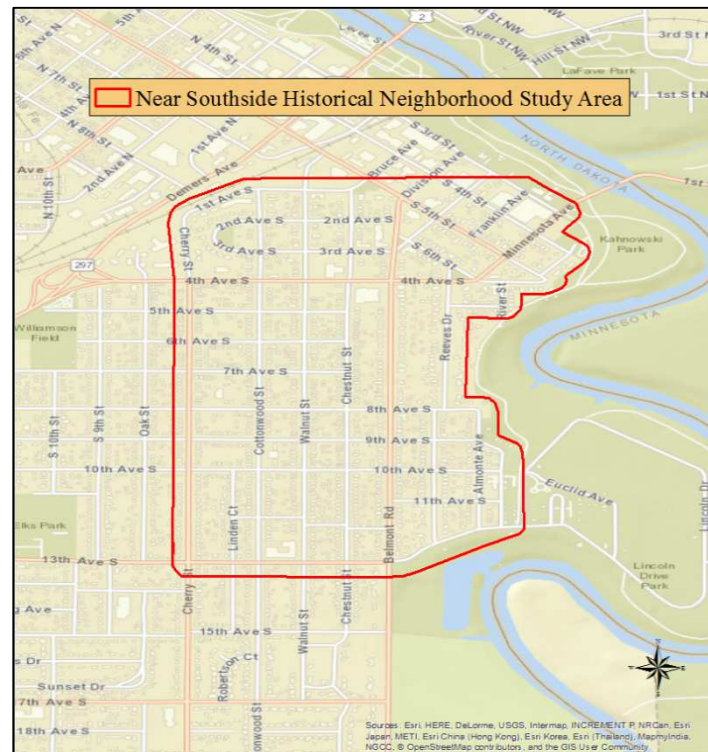
Figure 1. Study area

The Grand Forks-East Grand Forks Metropolitan Planning Organization (MPO), working with the City of Grand Forks (City) and the Near Southside Neighborhood Association requested the Advanced Traffic Analysis Center (ATAC) to explore possible traffic calming and safety countermeasures in the Near Southside Historic Neighborhood. The study area limits under consideration are 1st Ave. S. to the north, 13th Ave. S. to the south, Cherry St. to the west, and the Red River to the east. Figure 1 shows a general map of the area.

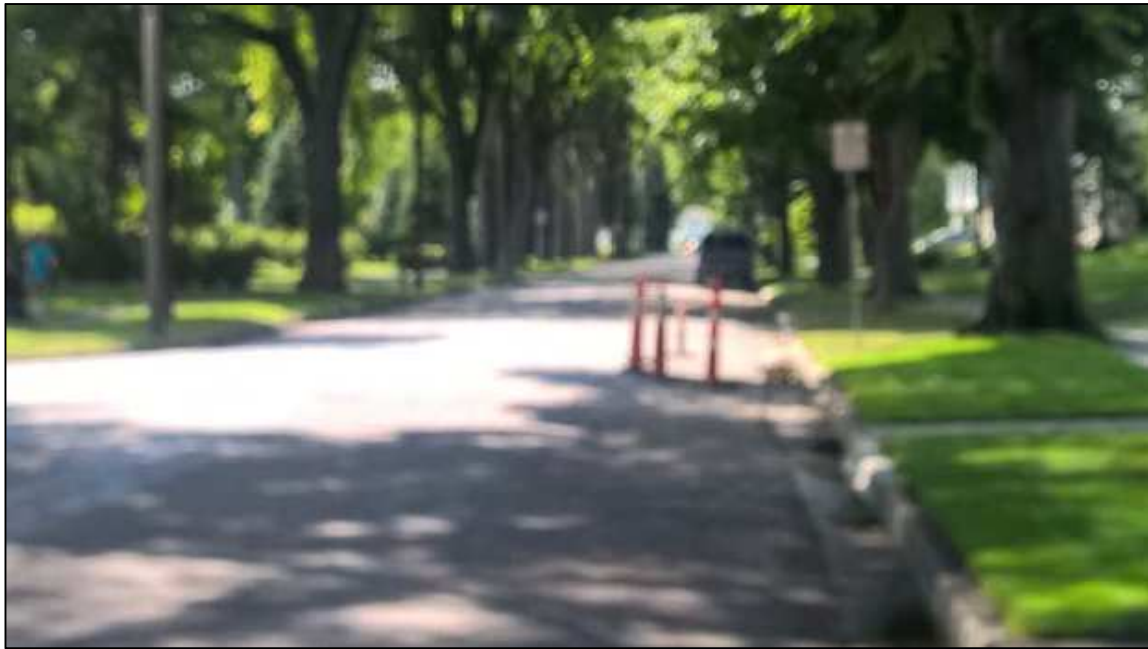
Figure 7. Reeves Dr. temporary improvement

A second traffic calming technique was temporarily installed at the intersection of Reeves Court and Reeves Drive. The curb was bulbed out on the west side. The distance from the curb was also replicating about what a parked vehicle would be into the street space. Figure 7 is a photo of the temporary bulb-out implementation. The thought behind this installation is that restricting the perception of street space available to drive would potentially result in reducing the speed.

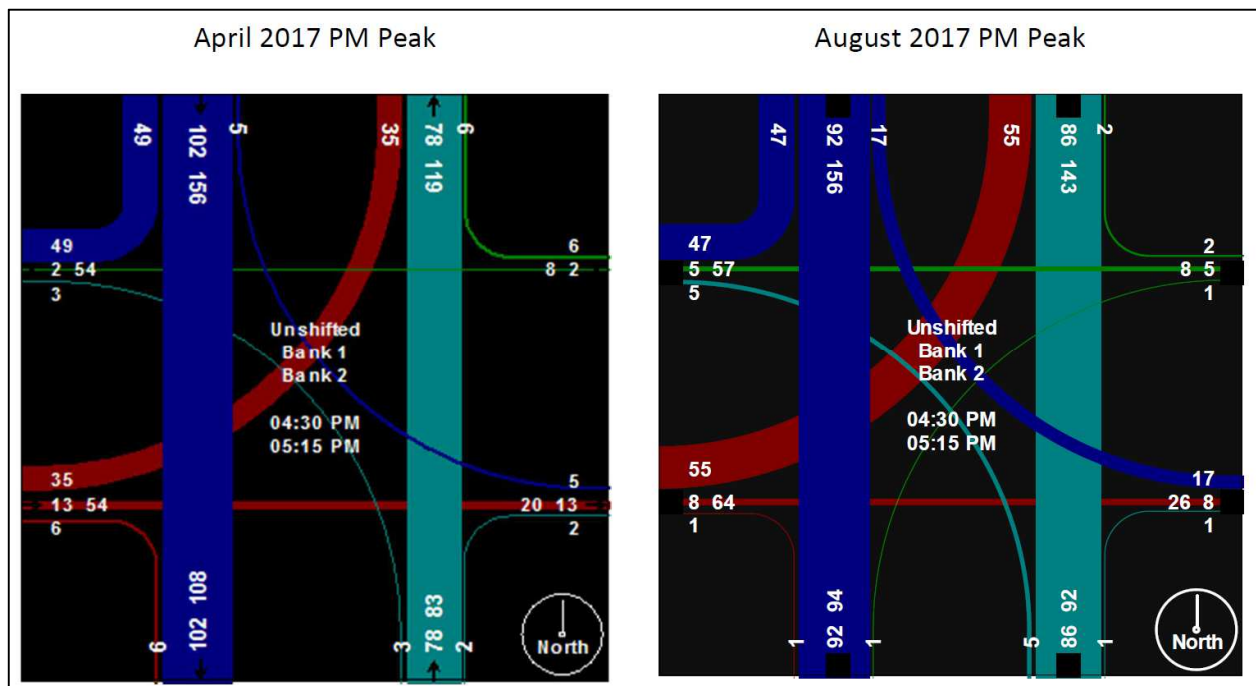
Figure 8. AM 8th Ave S Reeves Dr Intersection peak traffic counts

The turning movement counts themselves showed little difference in actual traffic counts. Figures 8 and 9 show the counts from April 2017 compared to the counts in August 2017. The AM Peak and PM Peak periods are used to show representative comparisons. The analysis would suggest that the technique did not divert any traffic to other routes. It would have been anticipated that there would be actually fewer vehicles than were counted. A typical traffic pattern in Grand Forks is that there are usually fewer vehicles traveling most streets in early August 2017 than are traveling in early April 2017. Schools not being in session yet in August 2017 are the biggest reason for this. At this intersection, the counts were not that much different, with even a slight increase in some movements.

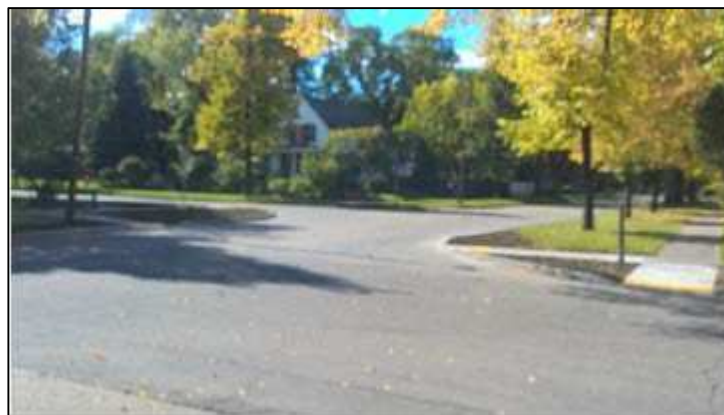
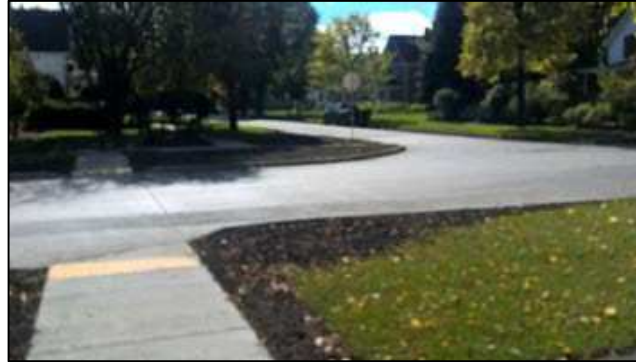
Figure 10. Reeves/4th Ave S curb extension

During the months of July and August of 2017, the neighborhood and city agreed to make the temporary traffic calming techniques more permanent. Concrete was poured to take the place of the bollards and traffic barricades. Curbs were installed and dirt with grass seed was installed where previous driving pavement existed behind the new curbs.

As seen in figures 10 and 11, the turning radius at the intersection was greatly reduced. Before, a vehicle could make the turning movements at a higher speed due in part to the allowance of a large turning radius. The reduction in radius was done on all sides of the intersection. This resulted in a much tighter space to make the movements necessary to continue through traffic movements. The stop condition was also enhanced by placement of the stop sign closer to the intersection.

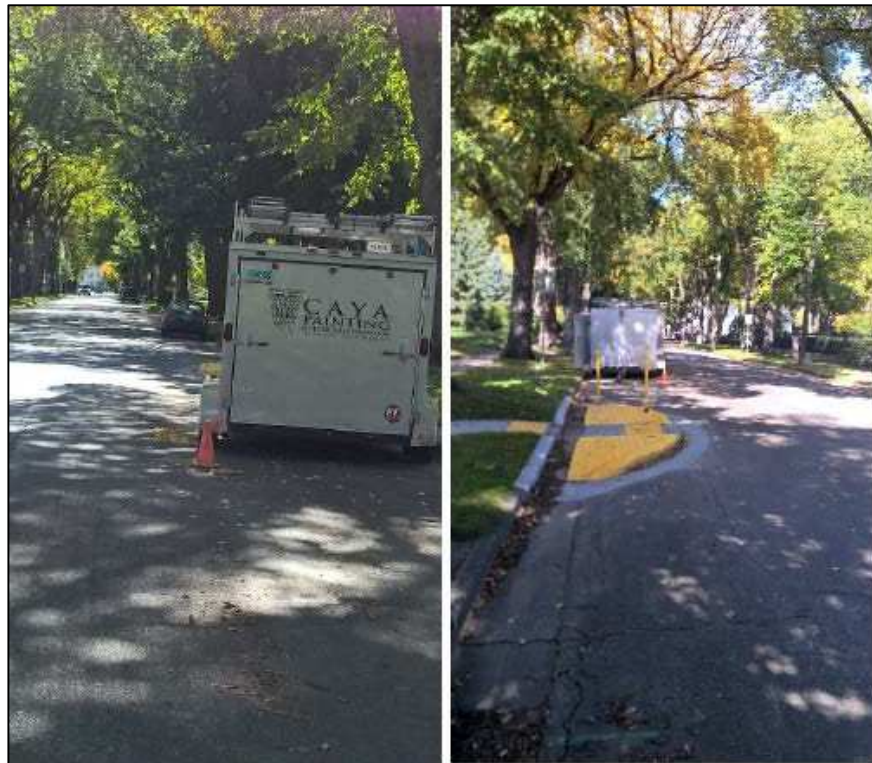
Figure 13. Reeves Drive bulb-out

The curb bulb-out at the intersection of Reeves Drive and Reeves Court was converted from its temporary materials to the concrete installation shown in Figure 13.

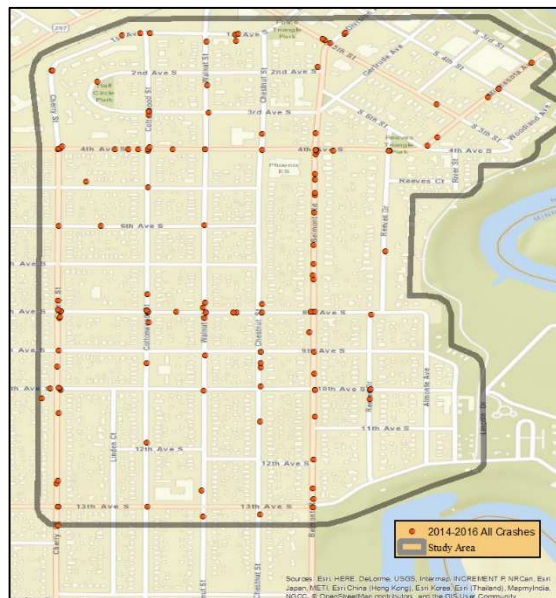
Figure 14. 2014-2016 study area – all crashes

Using the NDDOT crash summaries, which contained a shortened narrative of the crashes and more descriptive conditions, study area crashes were studied to identify any observable trends in crashes. Crashes within the study area for the years 2014-2016 are shown in figure 14.

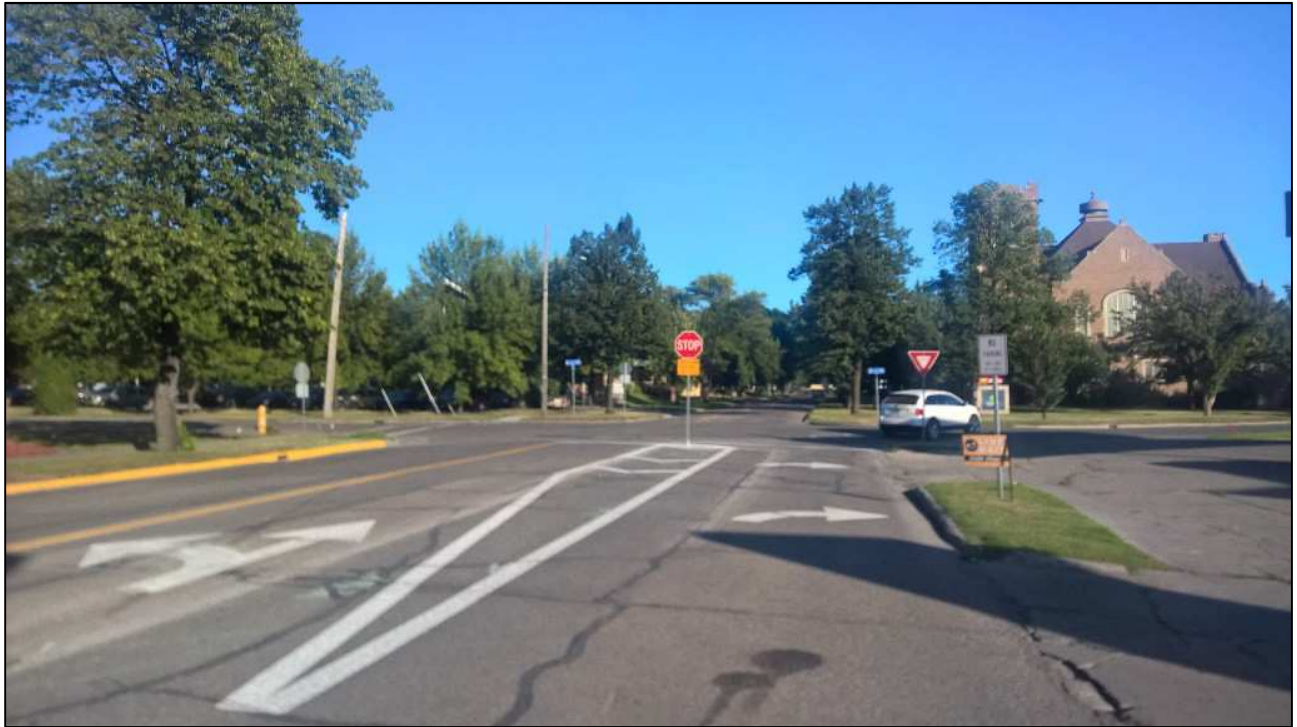
Figure 24. Belmont/5th/Division SB approach

This strategy was later augmented with the conversion of the southbound approach from 5th St. having the left turn lane and the through lane combined into one lane at the usual location of a left turn lane. The former space that was used for the through lane was striped to shift traffic away from the space so that a stop sign could be installed “in the middle of the street”. Hence, the left turn and through movements are controlled by the stop sign. The City installed a yield sign for the right turning movements so that they are directed to yield to traffic from Division Ave passing through the intersection. See Figure 24.

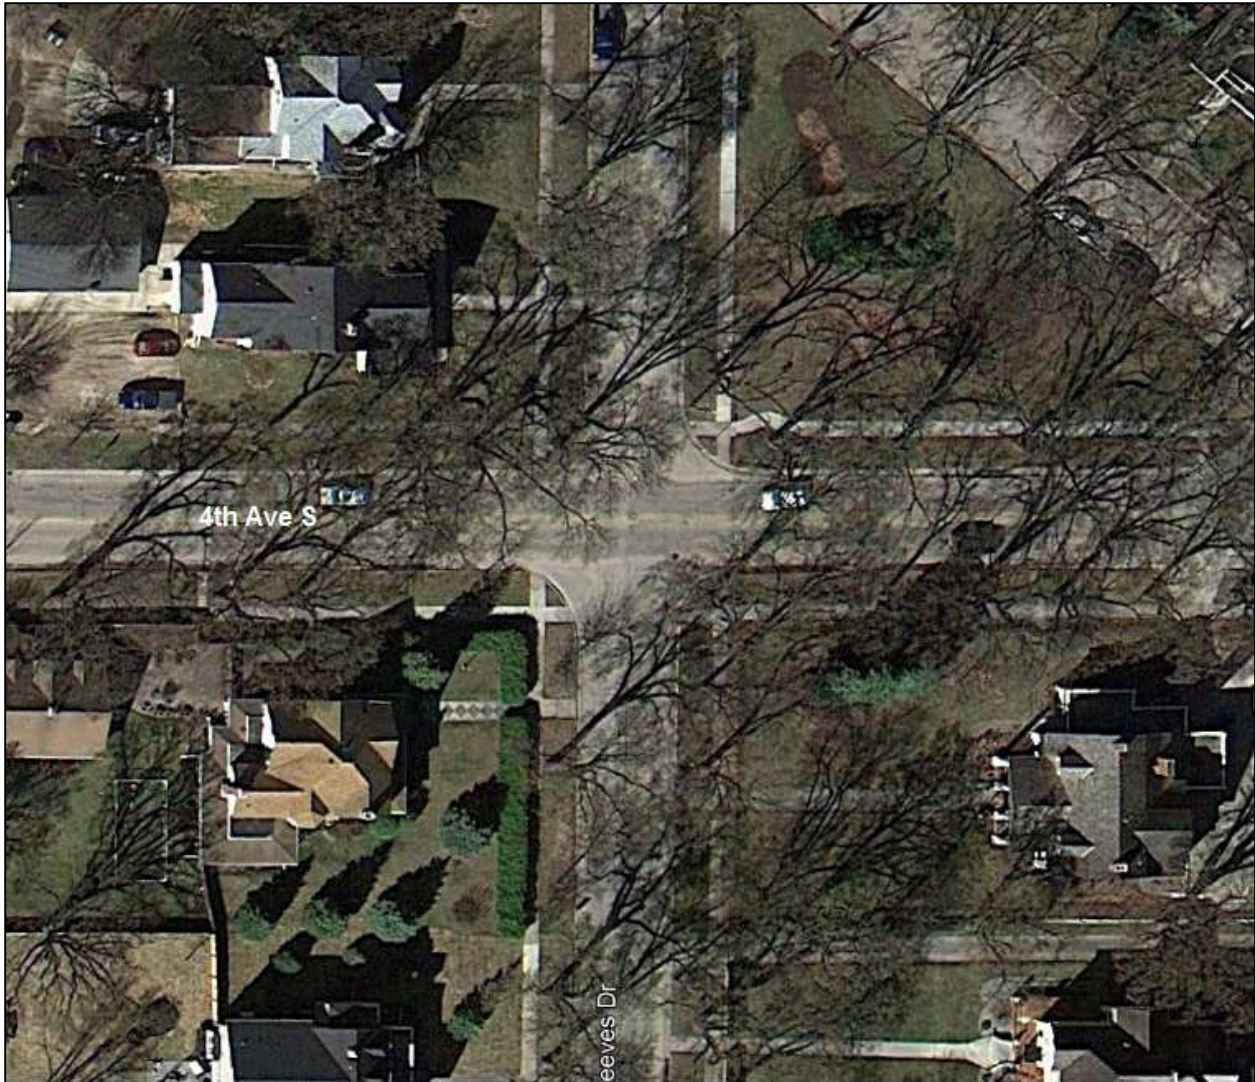
Figure 27. Reeves and 4th

As stated similarly in the previous intersection, 4th Ave. S. is a paved, two-lane, two-way, east/west Minor Arterial Street posted as 25 mph. It traverses the northern part of the city between Demers Ave and the state line with Minnesota and serves as primary access to the Point Bridge over the Red River of the North. The pavement width on 4th Ave S near Reeves Dr. is 30 feet wide and is striped for one lane in each direction and left turn pockets at the intersection. This area has mature landscaping/trees, there are no sight restrictions noted approaching the intersection or at a stopped position. West of the intersection is a "Your Speed" speed feedback sign facing the westbound lane. There is no traffic control for the east and west bound traffic. Parking is not permitted on either side of 4th Ave S. See Figure 27.

Reeves Drive is a paved, two-lane north/south local street, posted as 25 mph. The pavement width is 30 ft. and parking is permitted on the southbound lane and restricted only on Mondays from 8am to 4pm for the northbound lane. At the 4th Ave S intersection, north and south traffic is controlled by two-way stop control signs.

Observations have been reported that westbound vehicles coming from Point Bridge are traveling at a higher rate of speed. This can create hazardous conditions when entering the intersection and school zone.

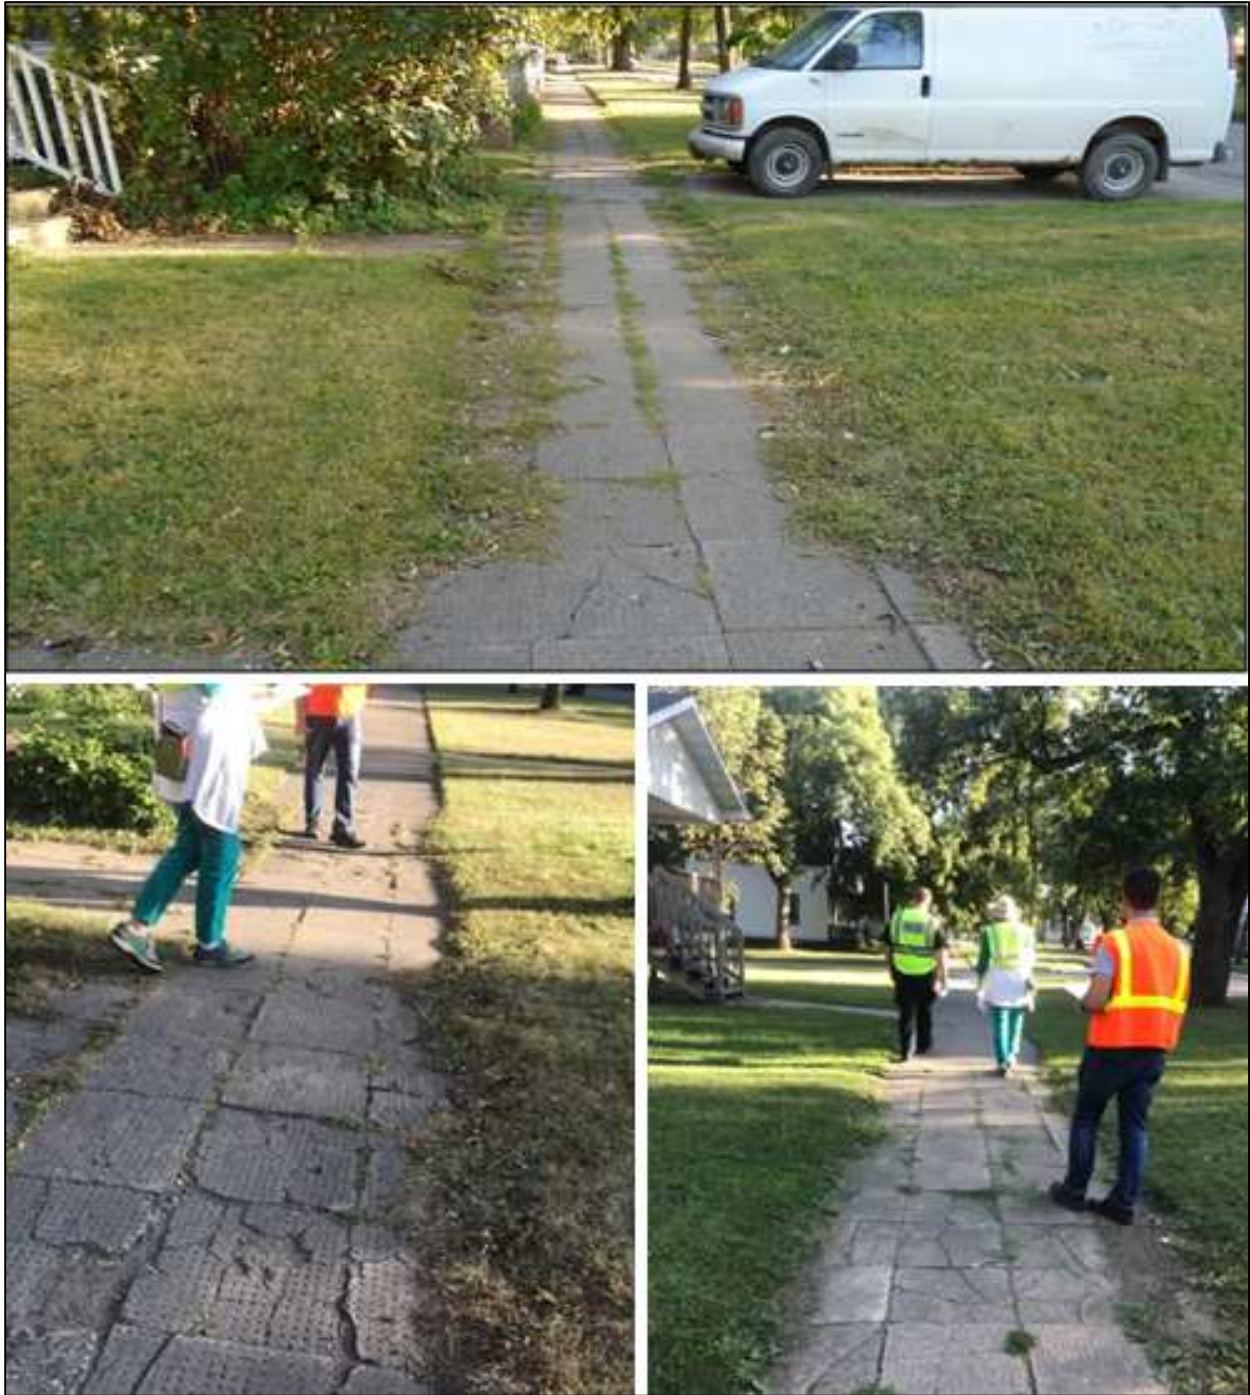
Figure 30. Sidewalk quality

For the assessment, sidewalk quality had the most negative impact towards the overall score. Throughout the study area there were repeated reports of the sidewalks being broken, cracked, or discontinuous, and being obstructed by objects or shrubbery.

Figure 30 shows images depicting the sidewalk quality issue in the neighborhood. Old/cracked sidewalk can be seen predominately along Cherry St.

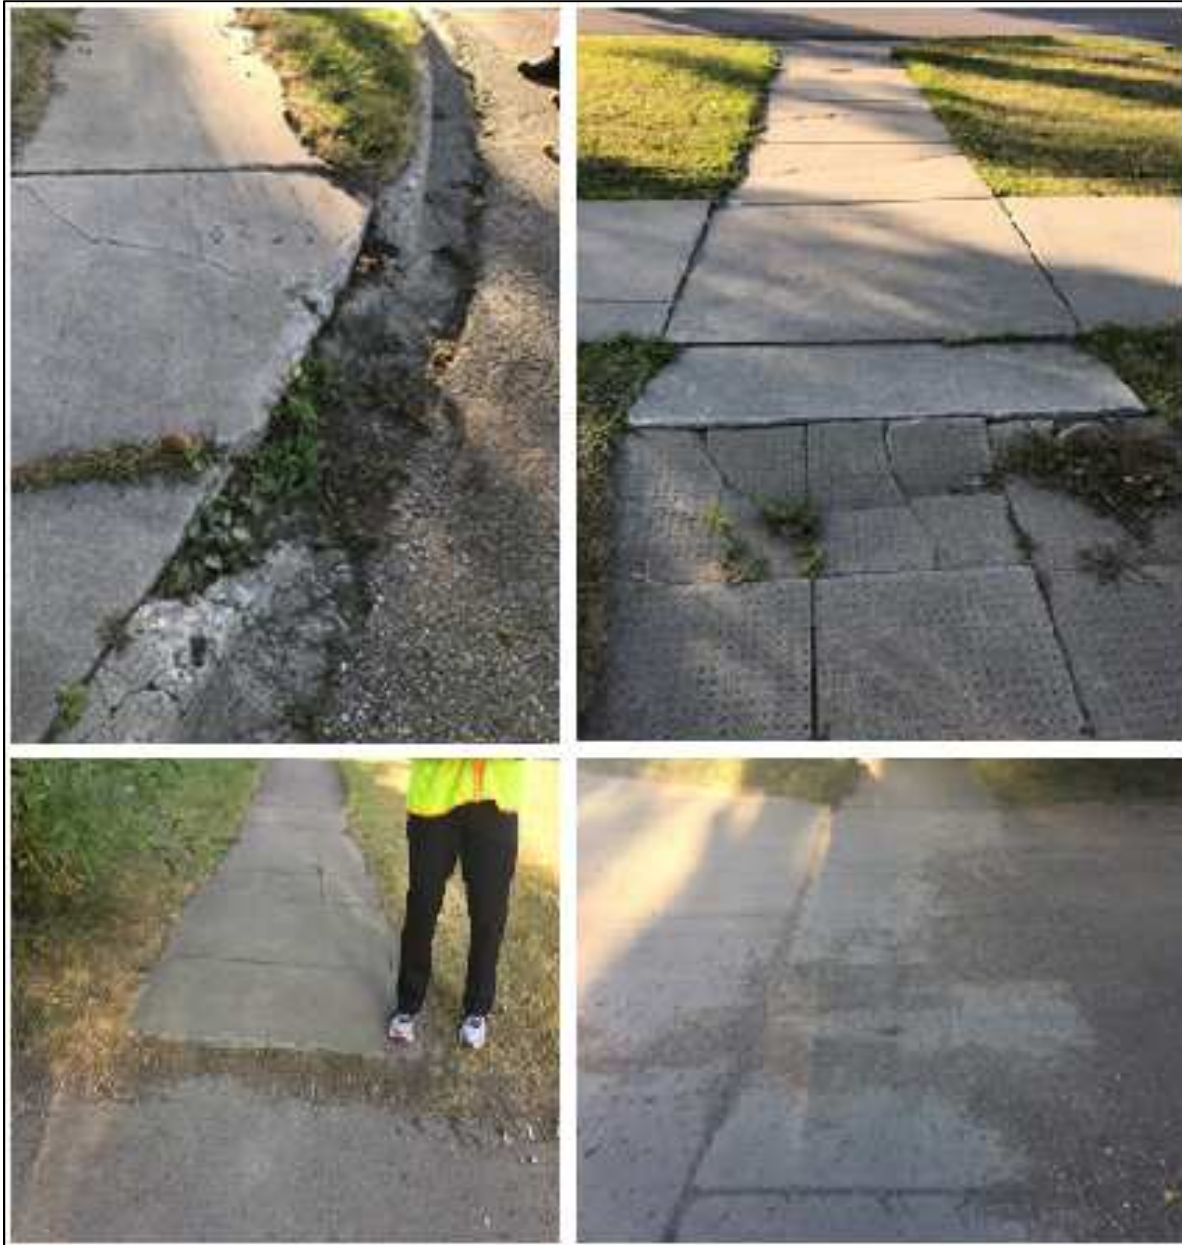
Figure 31. Sidewalk hazards

Figure 31 shows sidewalks in the neighborhood that are unsafe due to tripping or slipping hazards. These areas may be dangerous, especially when walking at night.

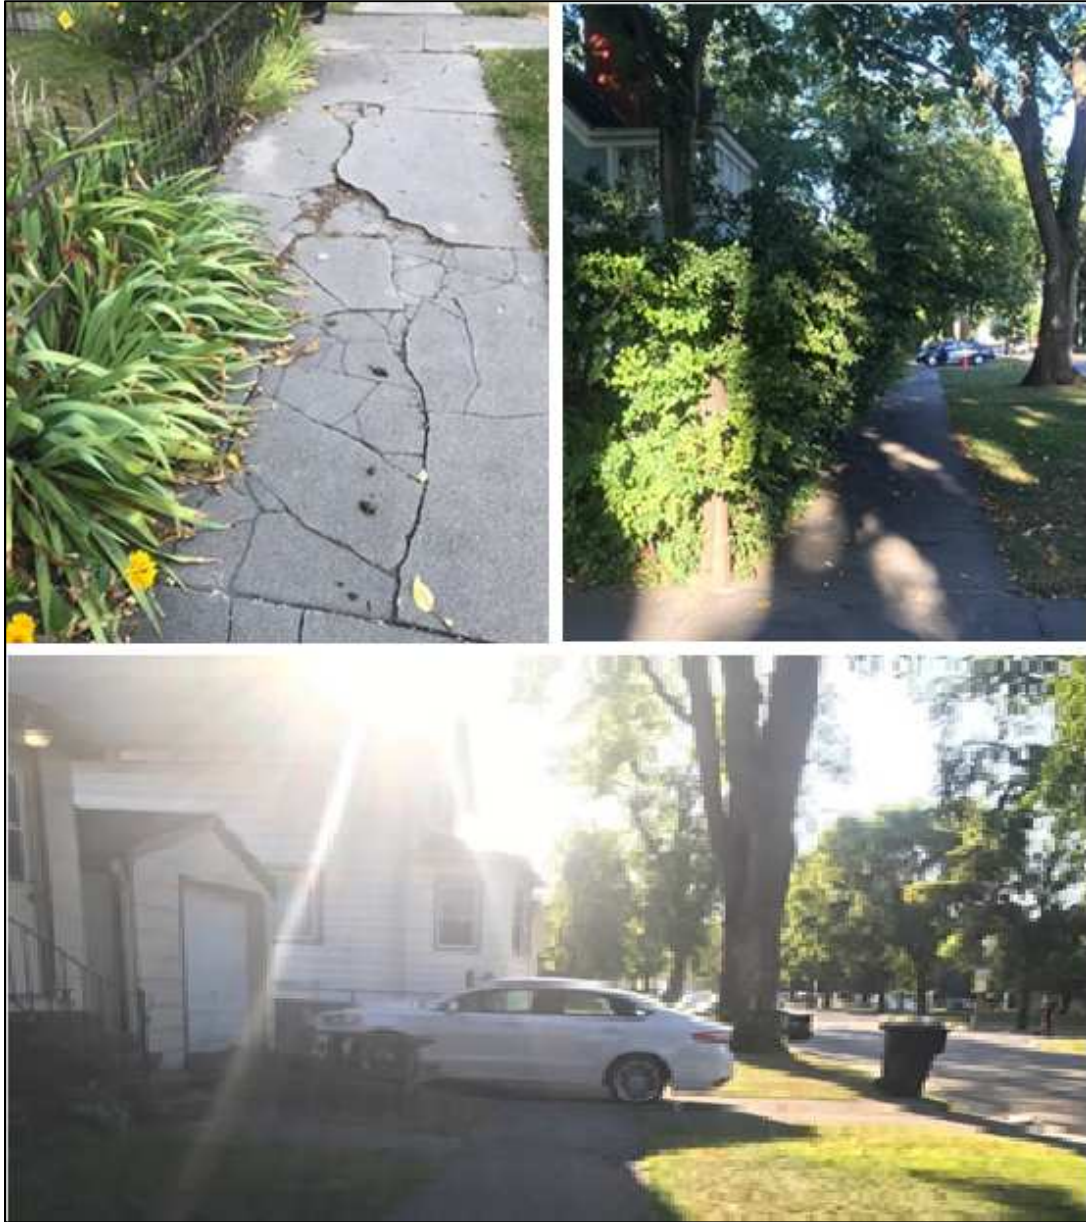
Figure 32. Sidewalk obstructions

Figure 32 shows a few images of the sidewalk blockage issue facing the neighborhood. Property owner negligence prohibits pedestrians from walking comfortably without obstructions.

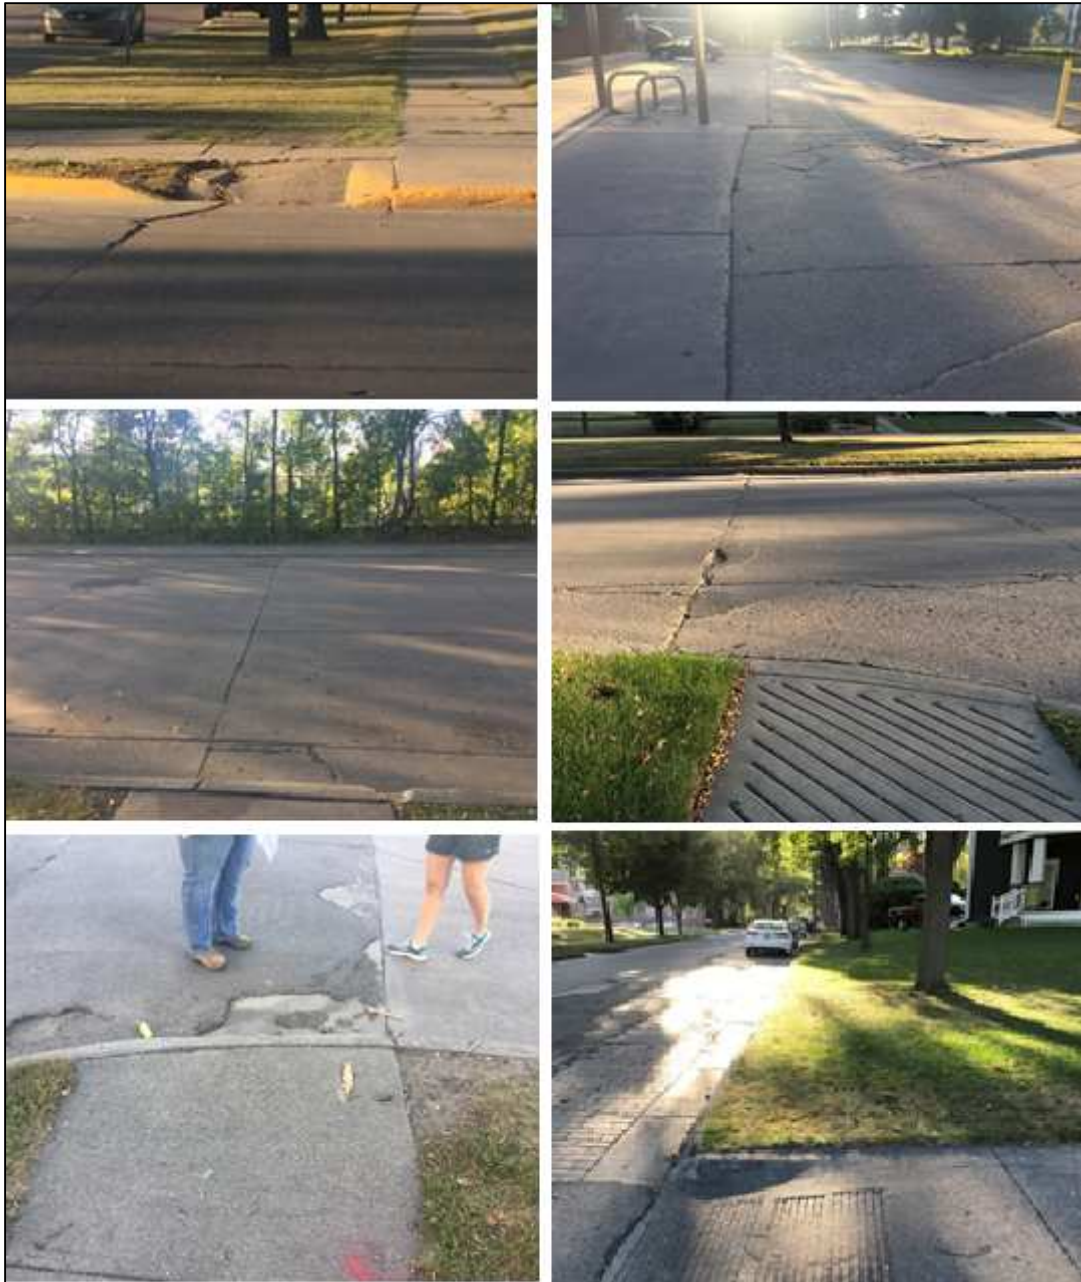
Figure 33. Sidewalk accessibility issues

Figure 33 shows a collection of images showing the accessibility issue in the neighborhood. Some areas provide access to a crosswalk on only one side of the street. Some of the crosswalk accesses do not provide a ramp into the street. In some cases, the sidewalk is not distinct. In others, there is no sidewalk along a section of the street, which forces the pedestrians in the neighborhood to walk unsafely within the vehicle travel lanes.

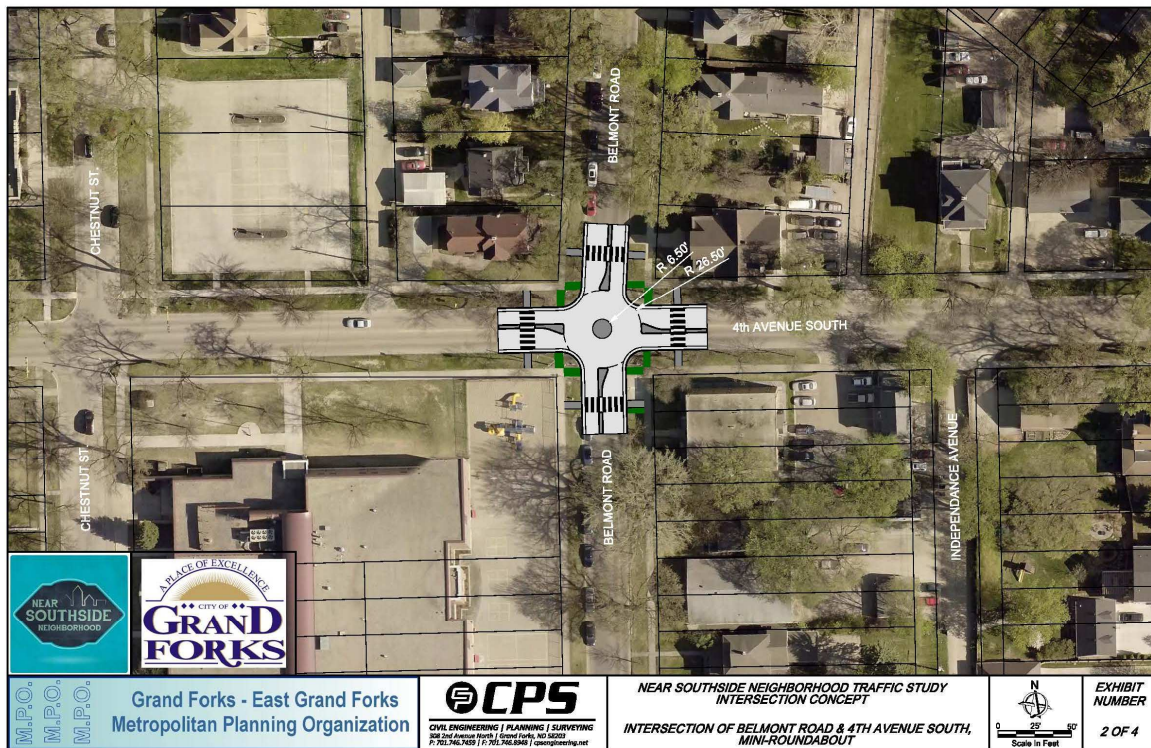
Figure 44. Belmont and 4th Ave S concept (not for construction)

With proper design, a roundabout could be a focal point where school buses, passenger cars, pedestrians such as school children, and bicycles are able to share the road safely. In the United States, roundabouts near school zones are slowly increasing in number. Further project development and traffic operations engineering will need to take place to convert these concepts into actual, functioning mini-roundabouts. The 2017 installation of push button red flashing lights at the stop signs at the intersection could be implemented, with revisions, as a pedestrian hybrid beacon with the mini-roundabout. Thus being able to stop traffic when a pedestrian, or bicyclists riding on the sidewalk, wish to cross the intersection.

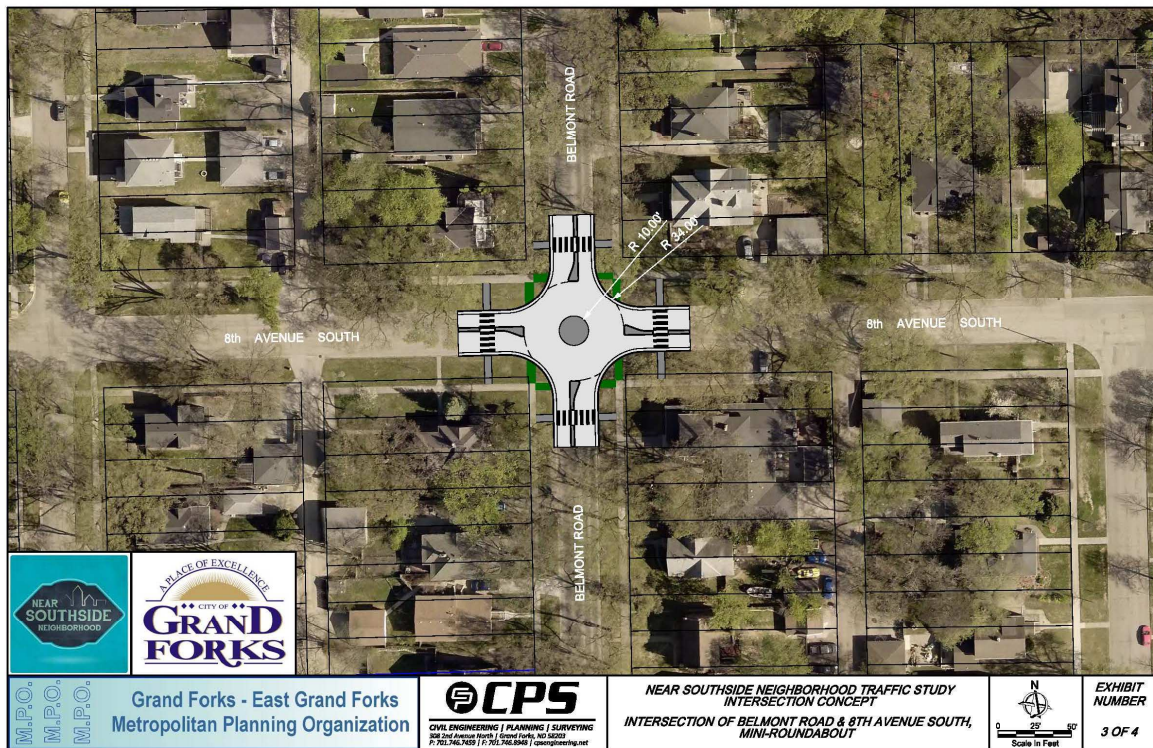
Figure 46. Belmont and 8th Ave S concept (not for construction)

Though this intersection does not experience a high number of crashes relative to the other intersections, this section of roadway desires calmer traffic speeds with improved traffic flow. Improving the traffic flow at this intersection encourages traffic along Belmont to not cut through to Reeves Drive. Residents near this intersection also expressed concern of vehicles “drag racing” once stopped at this intersection. The mini roundabout should eliminate this action as well as reduce any noise pollution caused by vehicles stopped and starting at the stop sign. Figure 46 shows the concept for this intersection.

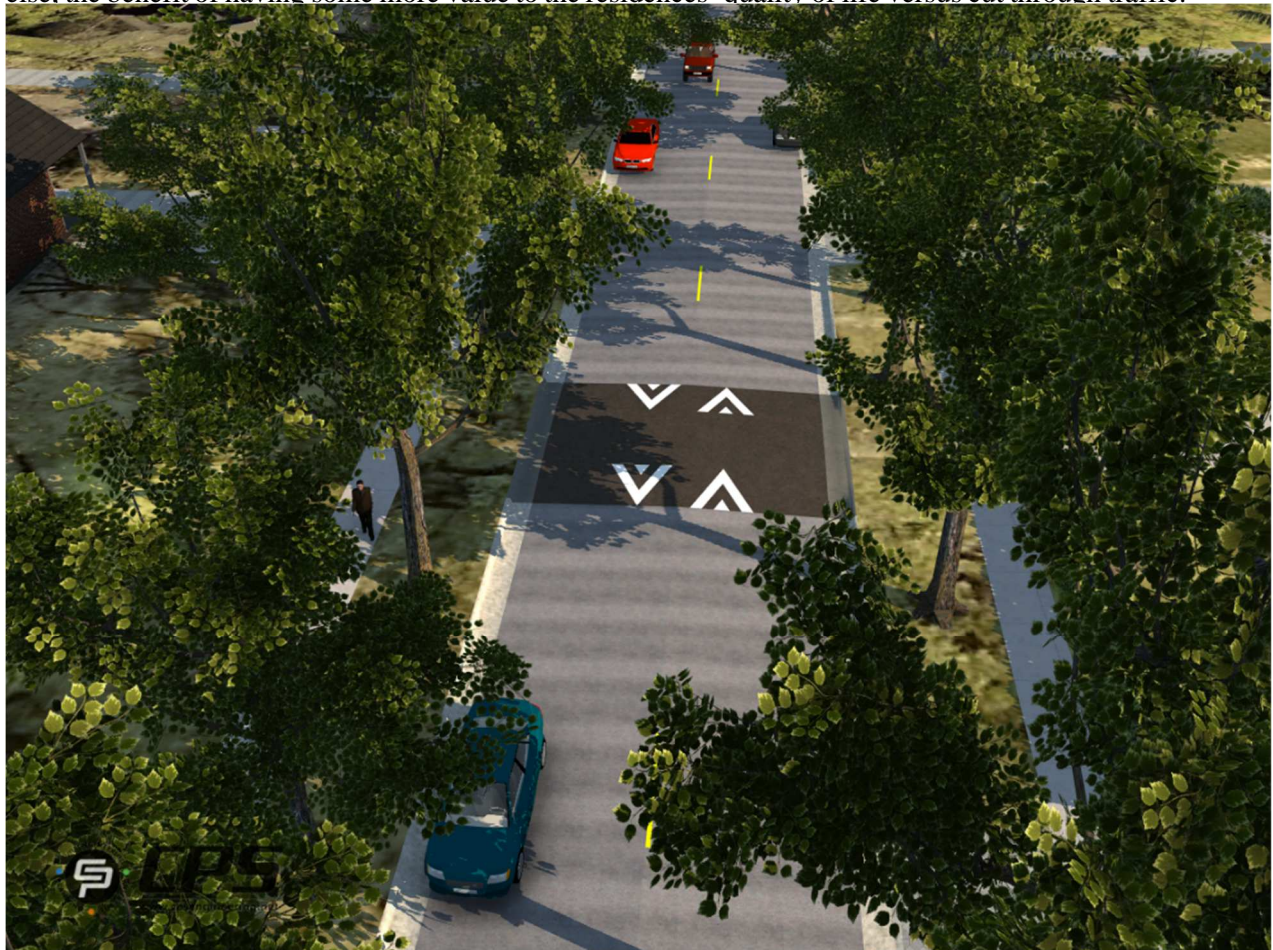
Figure 49. Speed Table concept (not for construction)

are midblock traffic calming devices that raise the entire wheelbase of a vehicle to reduce its traffic speed. Speed tables are longer than speed humps and flat-topped, with a height of 3–3.5 inches and a length of 22 feet. Spacing for vertical speed controls should be determined based on the target speed of the roadway. To achieve greater speed reductions, space speed humps or tables close together. They can be used with or without a pedestrian crosswalk at the highest portion of the feature and curb bulb-outs or extensions. See Figures 49 and 50.

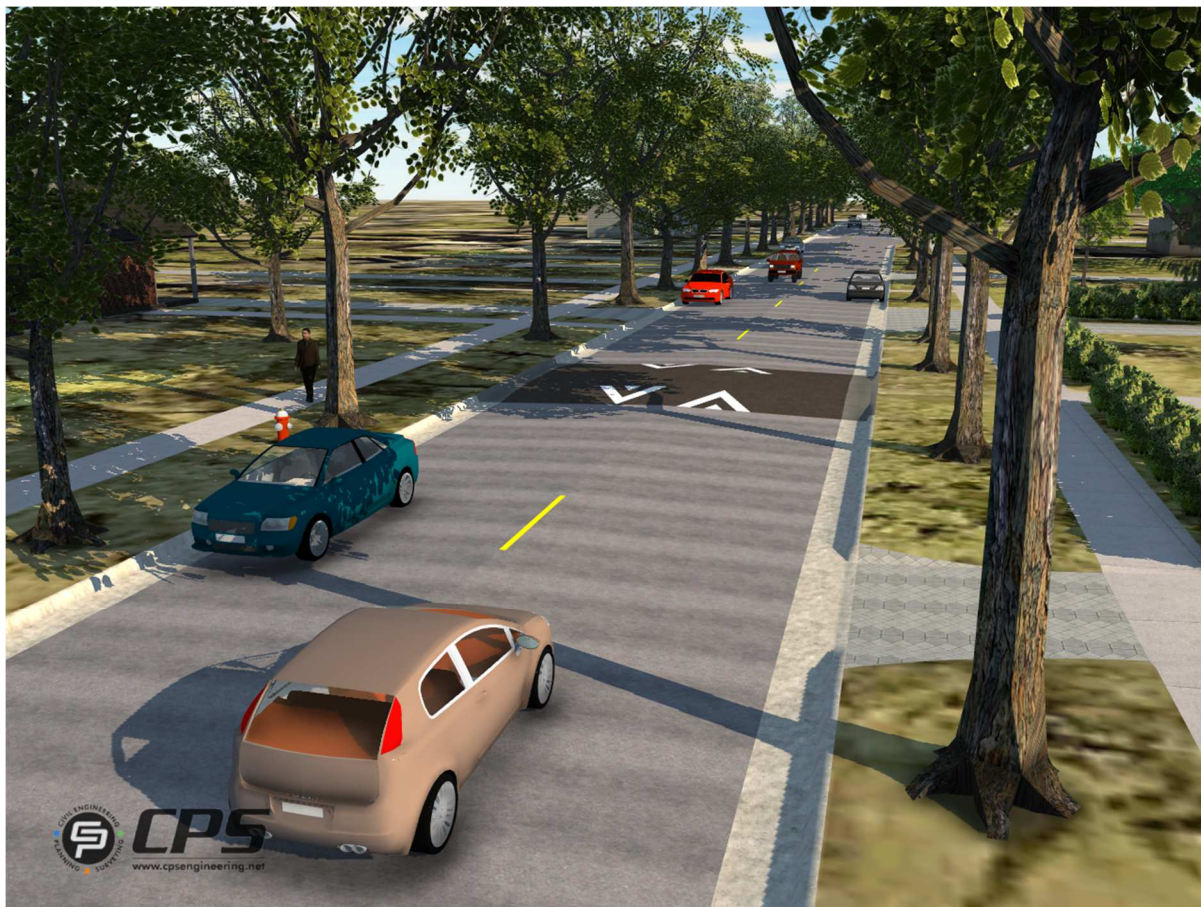
Figure 50. Speed Table concept (not for construction)

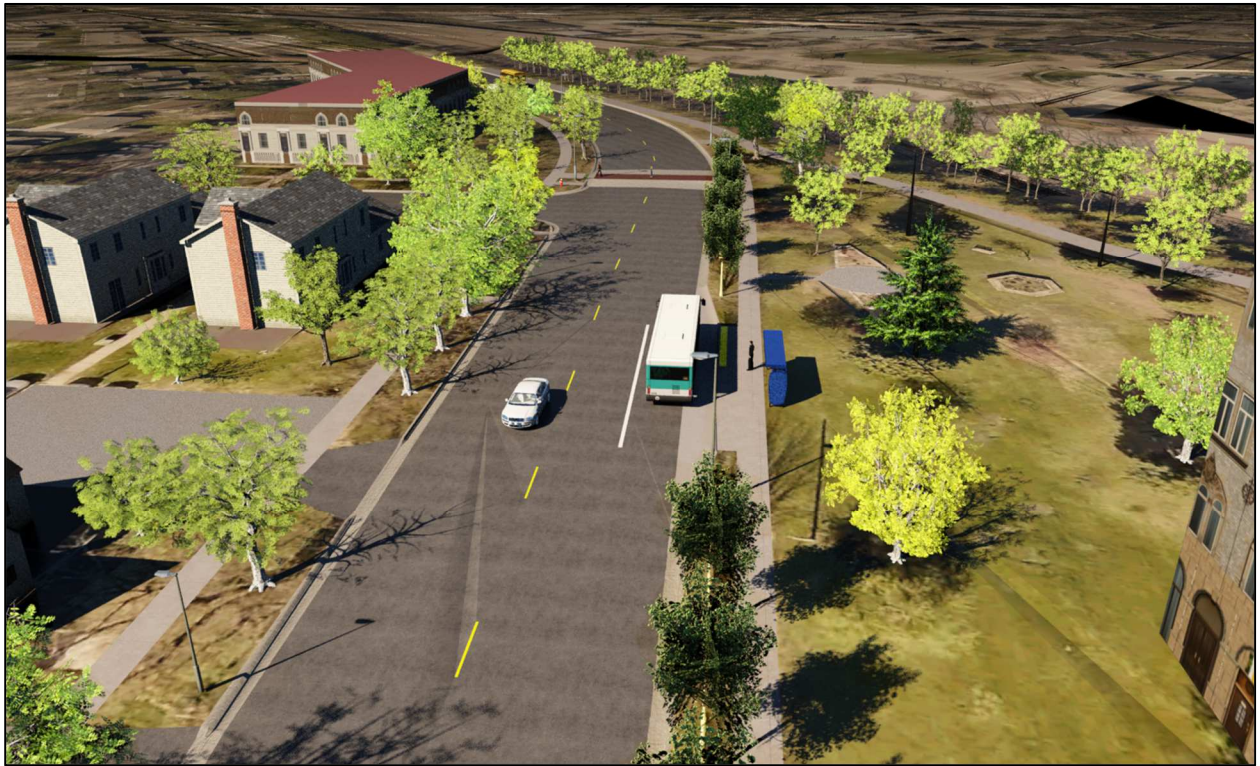
Figure 52. Bus stop concept

Some concepts have been developed showing how a new bus stop could be implemented. The intent is to locate it between the two main housing areas and also provide some traffic calming techniques. The concept tries to “land” the bus stop at a location that would allow the construction of a shelter. Given the already large number of passengers boarding, a shelter is needed. The current location of the bus stop does not provide room for a shelter given a multi-use trail exists at the curb. See Figure 52.
